## FIELD VISIT TO SUN/BHOTE KOSHI FOR THE CLIMATE REALITY PROJECT

23 JANUARY 2012, MONDAY

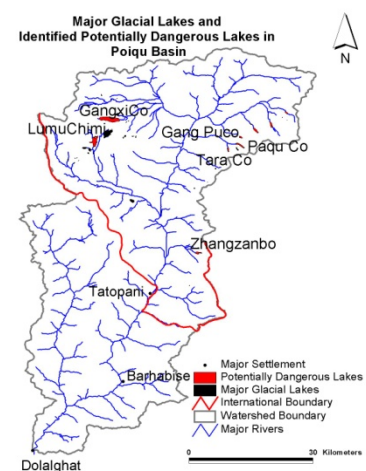
Figure 2: Major glacial lakes and identified potentially dangerous lakes in the Poiqu basin

The Tibetan side of the basin is heavily glaciated, while the Nepalese side has very little glaciated area. In 2000 glaciers covered  $231.58 \text{ km}^2$  – 7% of the whole basin and 11.5% of the Tibetan part of the basin. In 1988, the area covered by glaciers was  $243.86 \text{ km}^2$ . This suggests that the glaciers in the basin had shrunk by 5% in 12 years. The rapid deglaciation in the basin has resulted in the formation and growth of several glacial lakes. In 1988, there were 119 glacial lakes in the basin, covering  $13.42 \text{ km}^2$ . By 2000 the number had grown to 139 and the area of the lakes had increased to  $16.39 \text{ km}^2$ . This is equivalent to 18% growth of the lake area in 12 years. According to an ICIMOD analysis, there are 9 potentially dangerous glacial lakes in the basin (Figure 2). Temporal analysis of glaciers in this

basin shows that the number, area, and ice reserve are in a declining trend but the number of glacial lakes and their area are increasing. This clearly shows that the risk of glacial lake outburst flood in Bhote Koshi/Sun Koshi is likely to increase in the future.

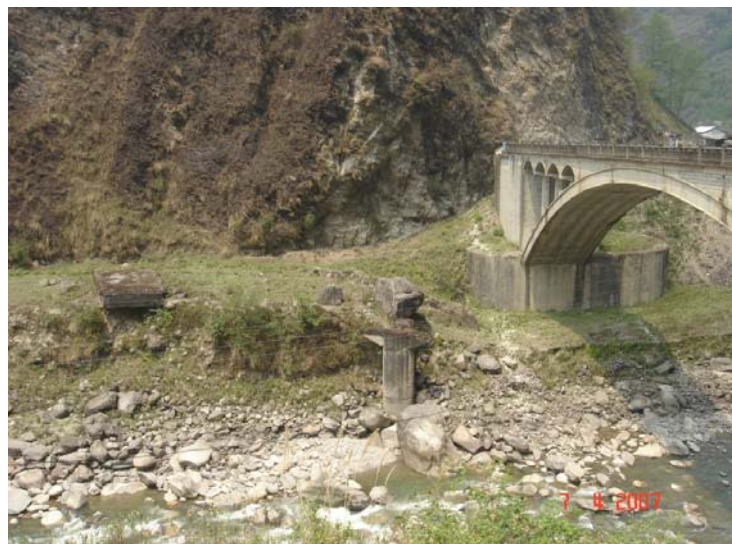
**Remnant of a bridge destroyed by the 1981 Zhanzanbo GLOF alongside the bridge constructed after the GLOF**

In 1964, Zhangzangbo Lake burst out. It was perhaps a partial outburst because of piping in the moraine dam. It did not cause remarkable damage. The same lake experienced an outburst on 11 July 1981. This GLOF caused significant damage, mainly in the Nepal part of the basin. The GLOF lasted for about 1 hour. The flood swept away 5 people, 41 houses, many water mills, and 2 highway bridges, including the Friendship Bridge at the China-Nepal border. In addition, 191 people were injured and 47 houses, 10 suspension bridges, and 8 culverts were damaged. The diversion weir of the Sun Koshi hydropower plant in Nepal was severely damaged by the GLOF. The total damage in Nepal amounted to about US\$ 3 million.
